## Eurasian Watermilfoil Meandering Survey for Lake Carlos, Douglas County, Minnesota, 2021

Eurasian Watermilfoil Meandering Survey: June 15, 2021

Prepared for:  
Lake Carlos Area Association  
Douglas County, MN

Prepared by:  
Steve McComas  
Blue Water Science  
St. Paul, MN 55116

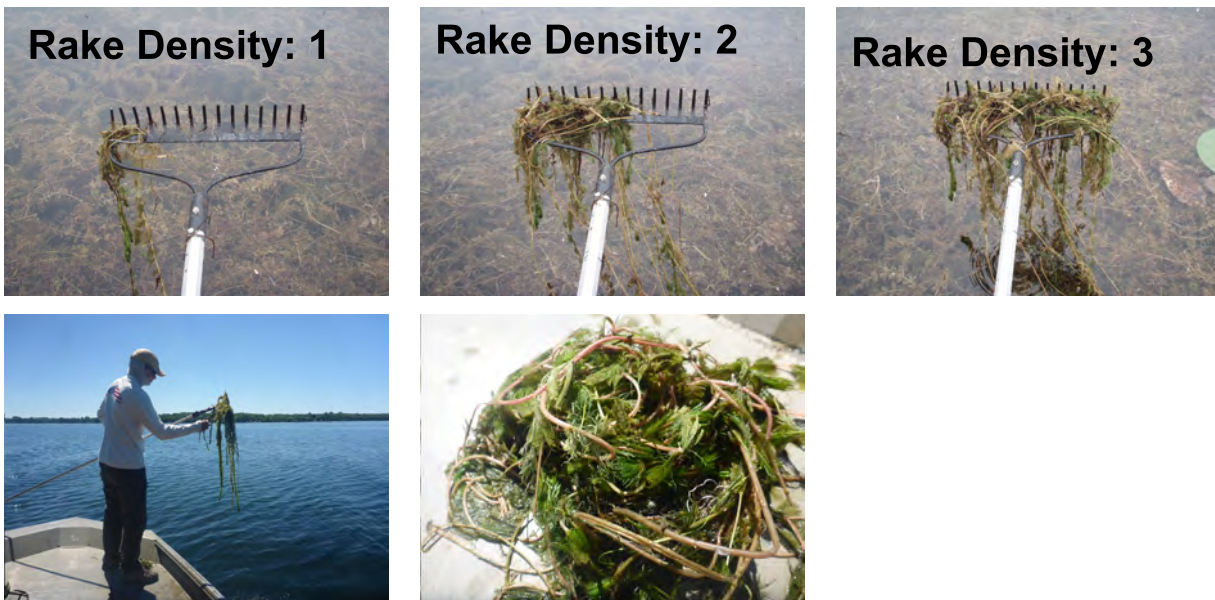
## Chart of EWM Density Ratings for EWM

Figure 2. Eurasian watermilfoil rake density ratings from 1 to 3. Milfoil that was sampled on the rake was collected in the boat and not returned to the lake.

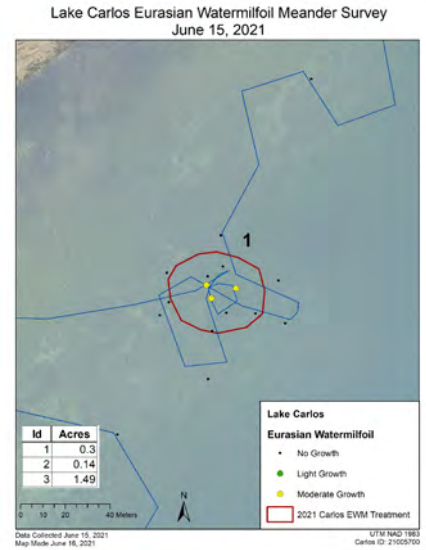
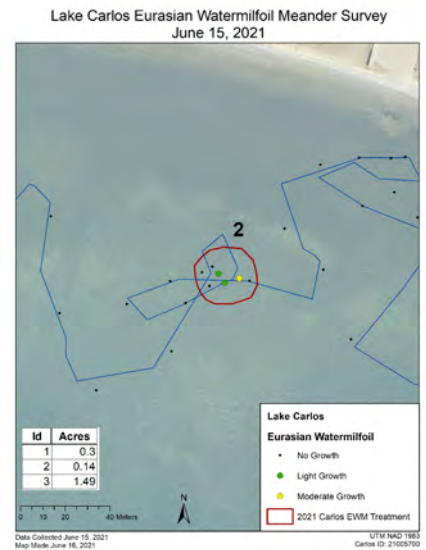
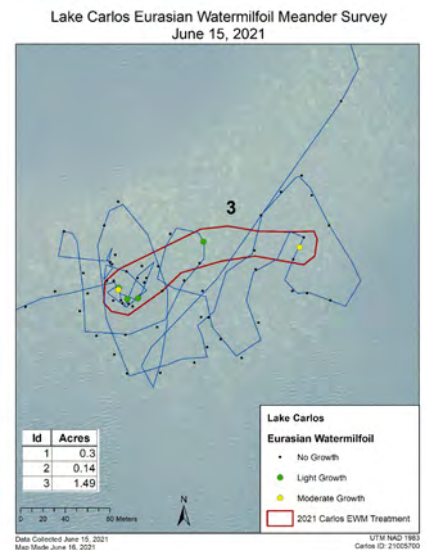
Lake Carlos Eurasian Watermilfoil Meander Survey  
June 15, 2021

Figure 3. [left] EWM delineation with 3 treatment polygons for June 15, 2021. [right] Close up of the 3 treatment polygons. Key: green dots = light growth, yellow dots = moderate growth, red dots = heavy growth, and black dots = no EWM growth.

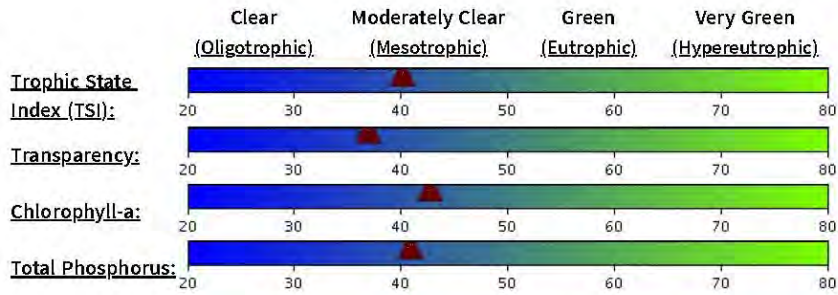
Overall Trophic State Index for This Lake: 40

Parameter	10-Year average of all summer samples	Parameter TSI	Expected TSI range for lakes in same ecoregion	Number of samples
Transparency (meters)	5	37	43 - 54	121
Chlorophyll-a (parts per billion)	3	43	46 - 61	106
Total Phosphorus (parts per billion)	13	41	49 - 61	106

The **Trophic State Index (TSI)** is a number that summarizes a lake's overall nutrient richness. Nutrient richness ranges from clear lakes, low in nutrients (oligotrophic), to green lakes, with very high nutrient levels (hypereutrophic). The chart to the left shows the overall TSI rating for this lake (top bar), followed by TSI ratings for the individual parameters that contribute to nutrient richness. The TSI calculations are based on data collected between June and September 1976 to 2018.

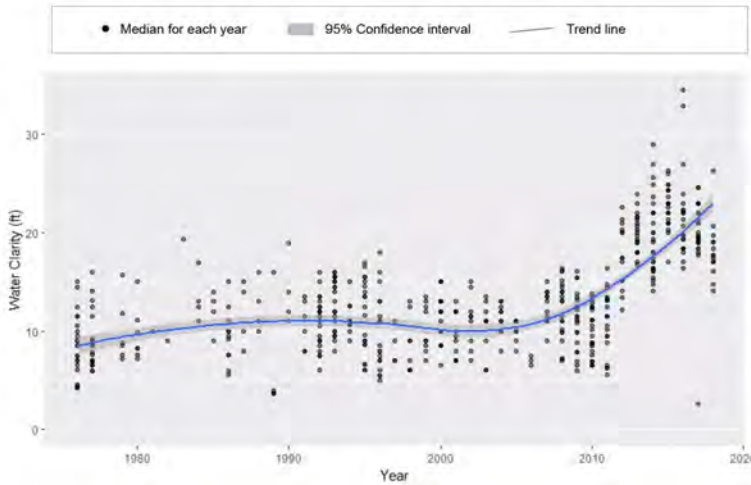
## Lake Transparency Trend

**Trend analysis result:** For years 1976 to 2018 there is evidence of improving water clarity at this lake, of approximately 1.4 feet per decade. For the most recent year of the analysis, median water clarity was 5.25 feet higher than the watershed median.
